RAILWAY INVESTIGATION REPORT

R03T0157

MAIN-TRACK DERAILMENT

**CANADIAN NATIONAL
TRAIN NUMBER A-450-31-21
MILE 68.9, BALA SUBDIVISION
GAMEBRIDGE, ONTARIO
21 MAY 2003**

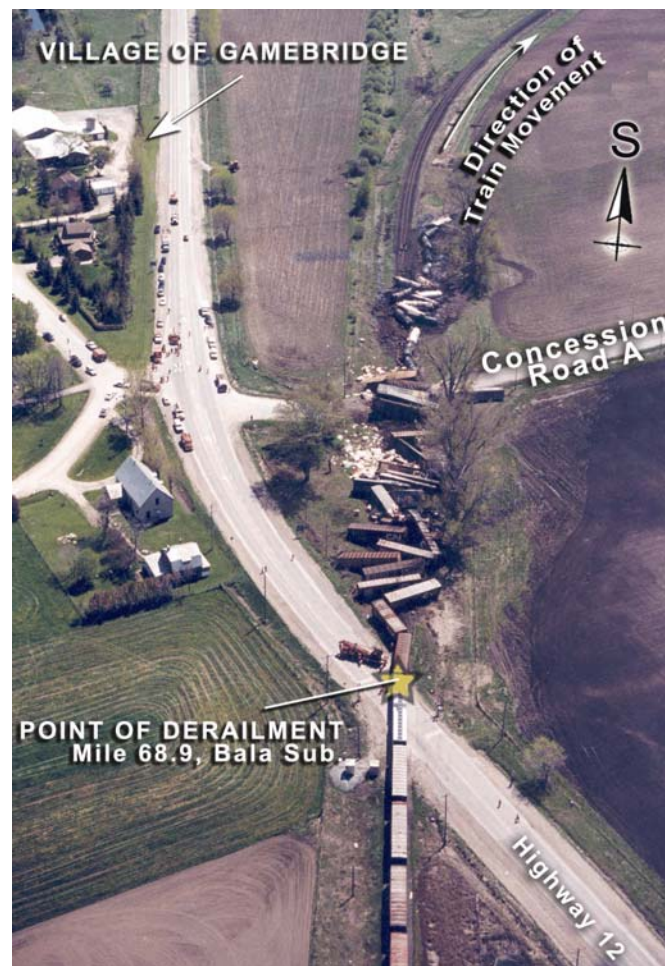
Photo 1. Aerial view of the derailment site, looking south

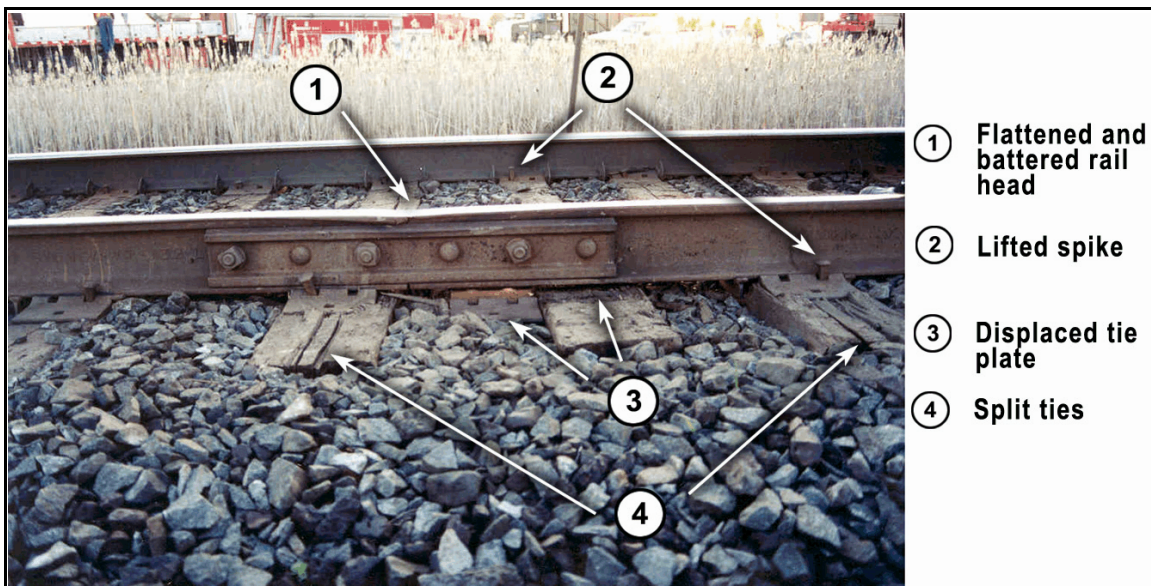
There were several joints on both rails just north of the crossing. One joint on the west rail was shimmed. An 18-foot rail plug was fully bolted in place on the east rail and both of the joints were battered. One joint was supported on two ties with only one tie plate (see Photo 2); the other had worked itself off the tie. A set of splice bars had also been applied to the east rail where the rail head was flattened and battered. Four bolts in the outer holes held the splice bars in place. There was also evidence of mud pumping and poor drainage, particularly at the joints north of the crossing (see Photo 3). An examination of several other road crossings within 10 miles of the derailment site revealed similar conditions.

Photo 2. Track condition at joint (Mile 68.9 of the Bala Subdivision, just north of Highway 12)

Track measurement north of the crossing under a loaded car, during the afternoon of the derailment, identified five near urgent cross-level tangent defects, two near urgent warp62 defects, and two urgent warp62 defects. These deviations were the result of a number of low, battered joints on defective ties in mud-fouled ballast.

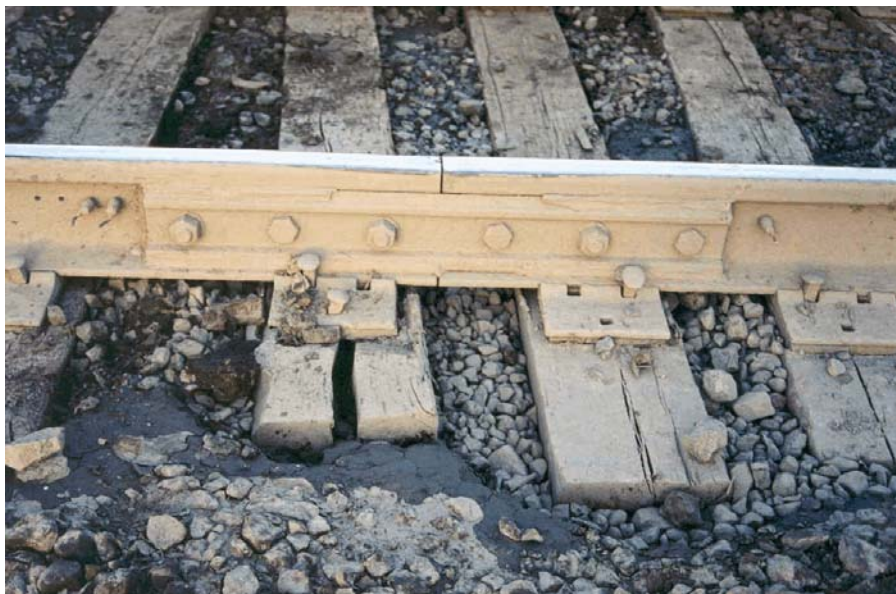
Photo 3. Close-up of joint north of Highway 12 crossing
